Warrenpoint Port

Maintenance Dredging 2024-2027

Information to Inform a Habitats Regulations Screening Assessment

November 2023 Updated March 2024

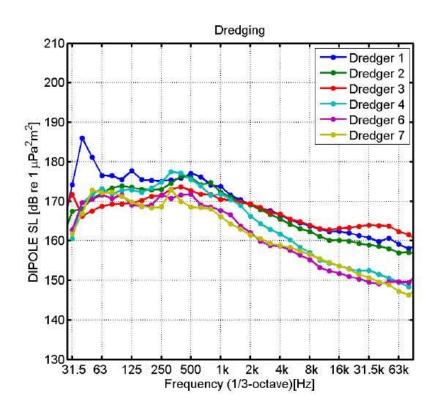
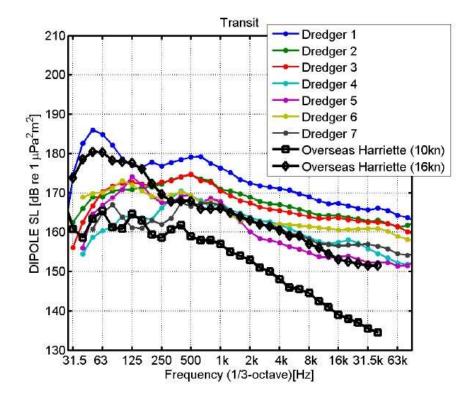
Figure A2.2 Noise Source Levels from Seven TSHDs during Construction of Massvlakte 2: Dredging Activity (left) and Transiting Activity (right) (source: de Jong et al., 2010)

De Jong et al. (2010) recorded and reported on the underwater sound levels generated by seven TSHDs working on the construction of a port development in the Netherlands, including the noise source levels generated during dredging and transiting activities. For both dredging activity (**Figure A2.2 left**) and transiting activity (**Figure A2.2 left**), the average noise source levels from the seven THSDs were generally below 180dB in the most sensitive hearing range for harbour seal (i.e., between 0.2kHz and 40kHz). For transiting activity (**Figure A2.2 right**), the average noise source levels from the seven THSDs were generally similar to or higher than the average noise sources from a transiting cargo vessel (*Overseas Hariette*) in the most sensitive hearing range for harbour seal (i.e., between 0.2kHz and 40kHz). Propeller cavitation was believed to be the principal noise source from TSHDs during both dredging and transiting activity and from cargo vessel transiting activity, albeit subject to transiting speed.

It should be noted that the TSHD in this study was using dynamic positioning thrusters and, therefore, was believed to have generated higher sound levels than would be typically expected for TSHDs where the principal sound source relates to propeller cavitation.
