**How does Nippon Gases react to the unrest this weekend, at which police were in attendance, when members of the public attempted to block the lorry carrying canisters to drive into the storage facility? Is this something that's happened at your other facilities before?**

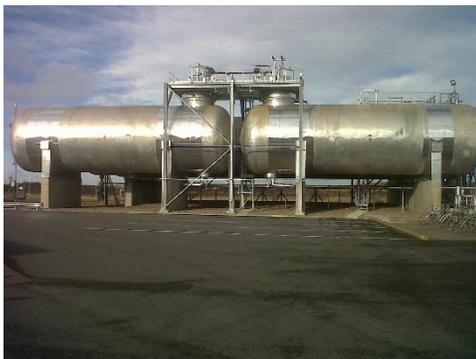
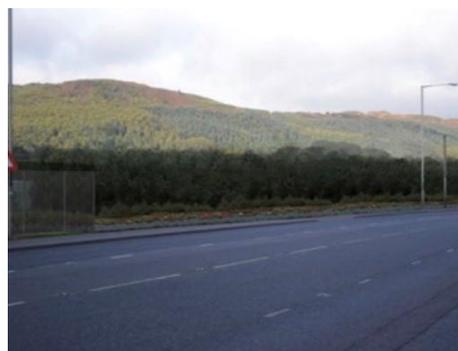
**Image of Tank after Replacement of Installation & Cladding and View from A2 when trees mature**

The specific tank pictured is one of four re-deployed from the NG shipping fleet. The "poor visible condition" is cosmetic as the pressure tank is surrounded by 200mm of polyurethane foam insulation and a 2mm aluminum cladding. The cladding and insulation is disrupted when the tank is removed from the ship and transported. What appears to be rust is discolouration of the insulation. The external appearance is not relevant in relation to the integrity of the pressure vessel, which is in excellent condition and definitely fit for purpose. As required by law, all of the tanks at Warrenpoint will be re-certified in accordance with current Pressure Systems Safety Regulations before use, and at regular intervals afterwards. The disrupted insulation and cladding will be replaced with new when the facility is close to completion. Please see Image Below.

There are also rigorous landscaping conditions that will ultimately screen the tanks, and NG will fully comply with these conditions. Indeed, NG believe that the "visual impact" of the facility from some critical views is already less than projected at the time of the application.
