PRACTICAL
WASTE SOLUTIONS

Independent Environmental Report

Warrenpoint Harbour Authority

Report Reference WHA 2401

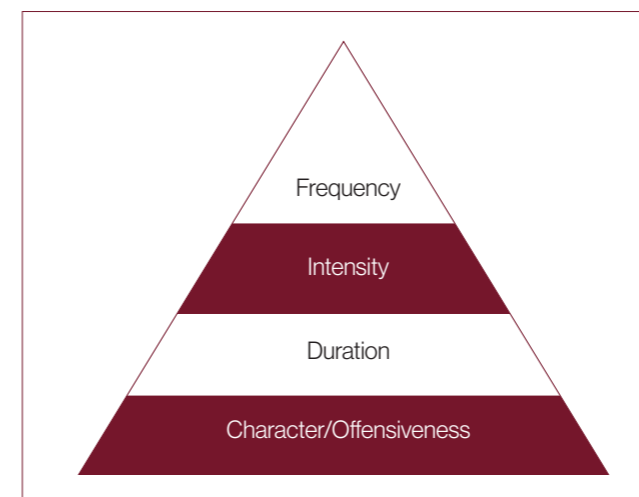
FIDOL PYRAMID

The FIDOL is a conceptual model used to help define what makes an odour episode become a citizen complaint is the pyramid-style hierarchy (above) consisting of four parameters:

- (1) Character/Offensiveness,
- (2) Duration - The length of a particular odour event
- (3) Intensity - The individual's perception of the strength of the odour
- (4) Frequency - How often an individual is exposed to odour
